LINER WEAR MEASUREMENT

LDM is a SMART (Safe Measures, Accurate, Reliable & Time Saving) tool to analyse cylinder liner wear and clover-leafing.

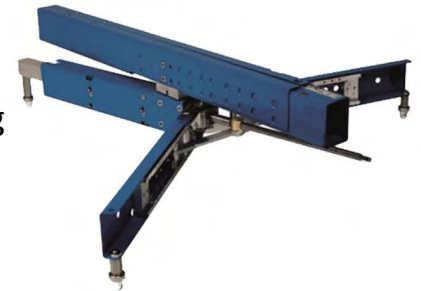
By using the LDM it is possible to avoid unplanned off-hire and reduce overhauling costs through continual monitoring of the cylinder condition.

Furthermore, pre-inspection of the cylinder condition before a piston overhaul will minimize downtime and cost.

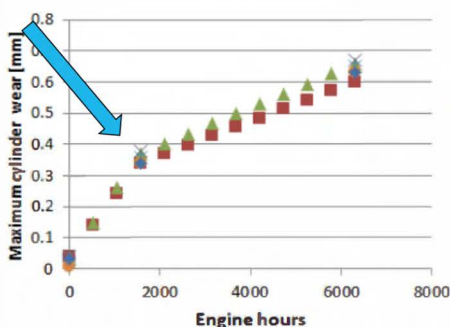
In the above example, monthly LDM measurements were done for a new engine in units # 1 and #2. The wear rate was found to be too high (0.2mm / 1 000h) and the root cause was traced as cold corrosion. The counter-measures included introduction of a new lubricant and to increase the cylinder wall temperature. The result could be clearly seen as reduced cylinder wear rate.

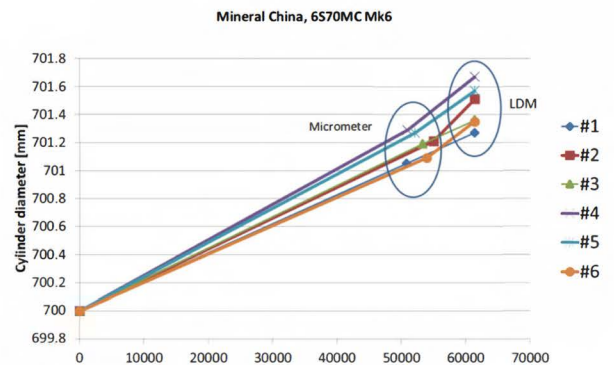
The diagram on the right, indicates that all six cylinders were first measured manually with micrometer on six different occasions. During such measurements, the cylinder cover must be taken off and the procedure takes about one day per cylinder for a three-man team.

With the LDM, the same six cylinders could be measured on one working day and by one operator. The results were very similar.

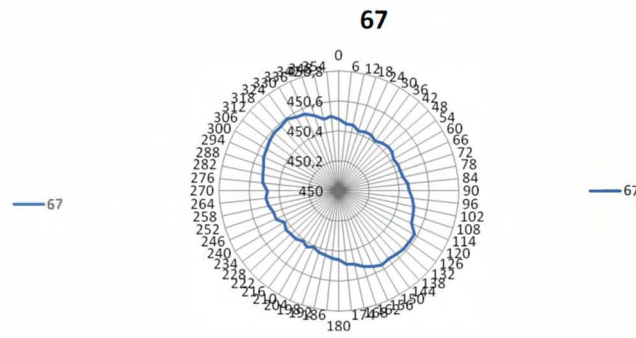
Cylinder 3, normal ovality. The normal ovality shape for this engine is in the port-starboard direction (0 degrees is port in the plot)

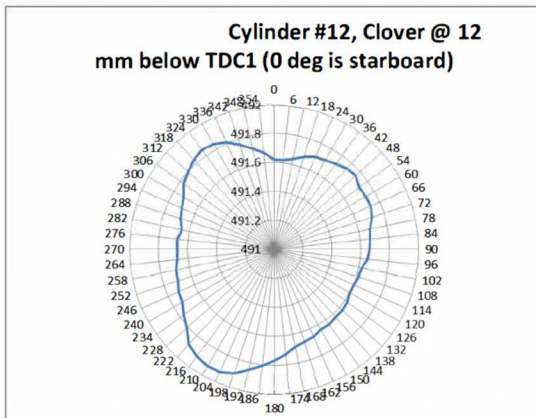
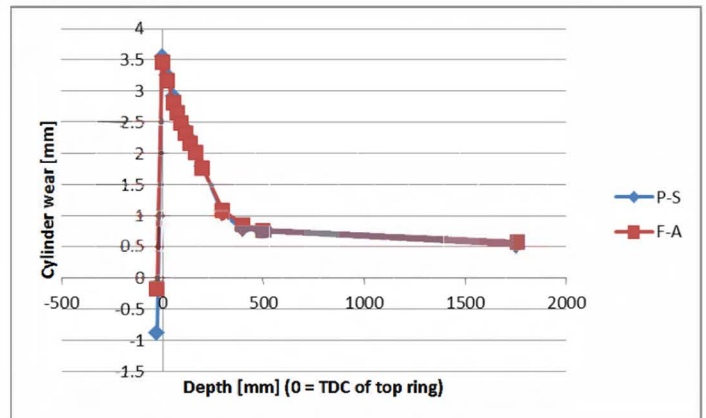
EXAMPLE 2: K98

Injection nozzle related wear. The three injectors have caused erosion in the cylinder liner, turning it into a three-clover. The diameter in the P-S and F-A directions are identical so no abnormality is picked up from a wear measurement. However, the clover measurement reveals that the cylinder is in poor condition and in need of honing or replacement

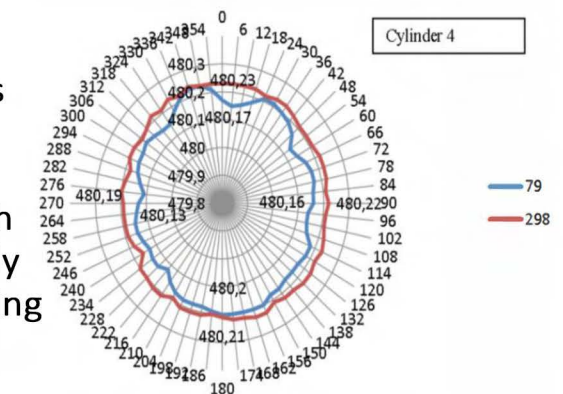
EXAMPLE 3: RT FLEX 96

The image shows two clover-leaving measurements at 79mm and 298mm below top ring TDC. Some clover shape can be seen at 79mm with peaks about 0.10mm higher than the valleys. Such a wear pattern will generate blow-by and eventually collapsed or broken piston rings when the piston ring pack cannot seal tightly against the cylinder liner. Cylinder honing can restore the cylinder condition.

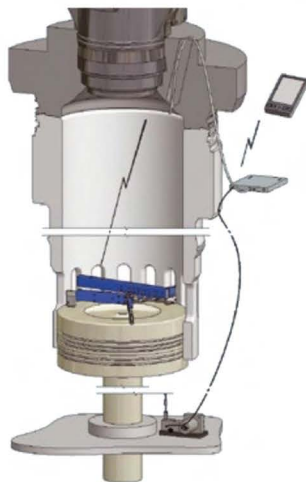
METHOD HOW IT WORKS:

- 1 A height meter indicates the piston level
- 2 The height meter is wired to an interface box
- 3 The interface box has an antenna connected to it
- 4 The antenna is inserted into the combustion chamber through a hole in the cylinder cover
- 5 The interface box communicates wirelessly with the measurement arm and base and a hand-held computer (PDA)
- 6 The measurement base locks against the liner with a support leg at each measurement level
- 7 The rotating measurement arm can measure wear (4 radii, 1 minute) or clover (36 radii, 4 minutes) on each level
- 8 The liner wall temperature is measured with an IR sensor and compared with the internal device
