# SMART LINER WEAR MEASUREMENT

LDM is a SMART (Safe Measures, Accurate, Reliable & Time Saving) tool to analyse cylinder liner wear and clover-leafing.

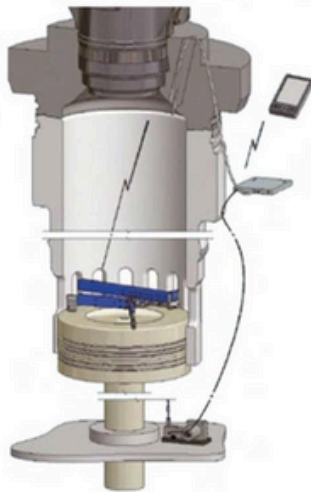
## METHOD HOW IT WORKS:

- 1 A height meter indicates the piston level
- 2 The height meter is wired to an interface box
- 3 The interface box has an antenna connected to it
- 4 The antenna is inserted into the combustion chamber through a hole in the cylinder cover
- 5 The interface box communicates wirelessly with the measurement arm and base and a hand-held computer (PDA)
- 6 The measurement base locks against the liner with a support leg at each measurement level
- 7 The rotating measurement arm can measure wear (4 radii, 1 minute) or clover (36 radii, 4 minutes) on each level
- 8 The liner wall temperature is measured with an IR sensor and compared with the internal device
